NEW MEXICO ENVIRONMENT DEPARTMENT

**Re: GCC Rio Grande, Inc.; Tijeras Plant; Minor Industrial; NPDES Compliance Evaluation
Inspection; SIC 3241; NM0000116; June 7, 2017**

**GCC Rio Grande, Inc. - Tijeras
Plant Compliance Evaluation
Inspection NPDES Permit No.
NM0000116**

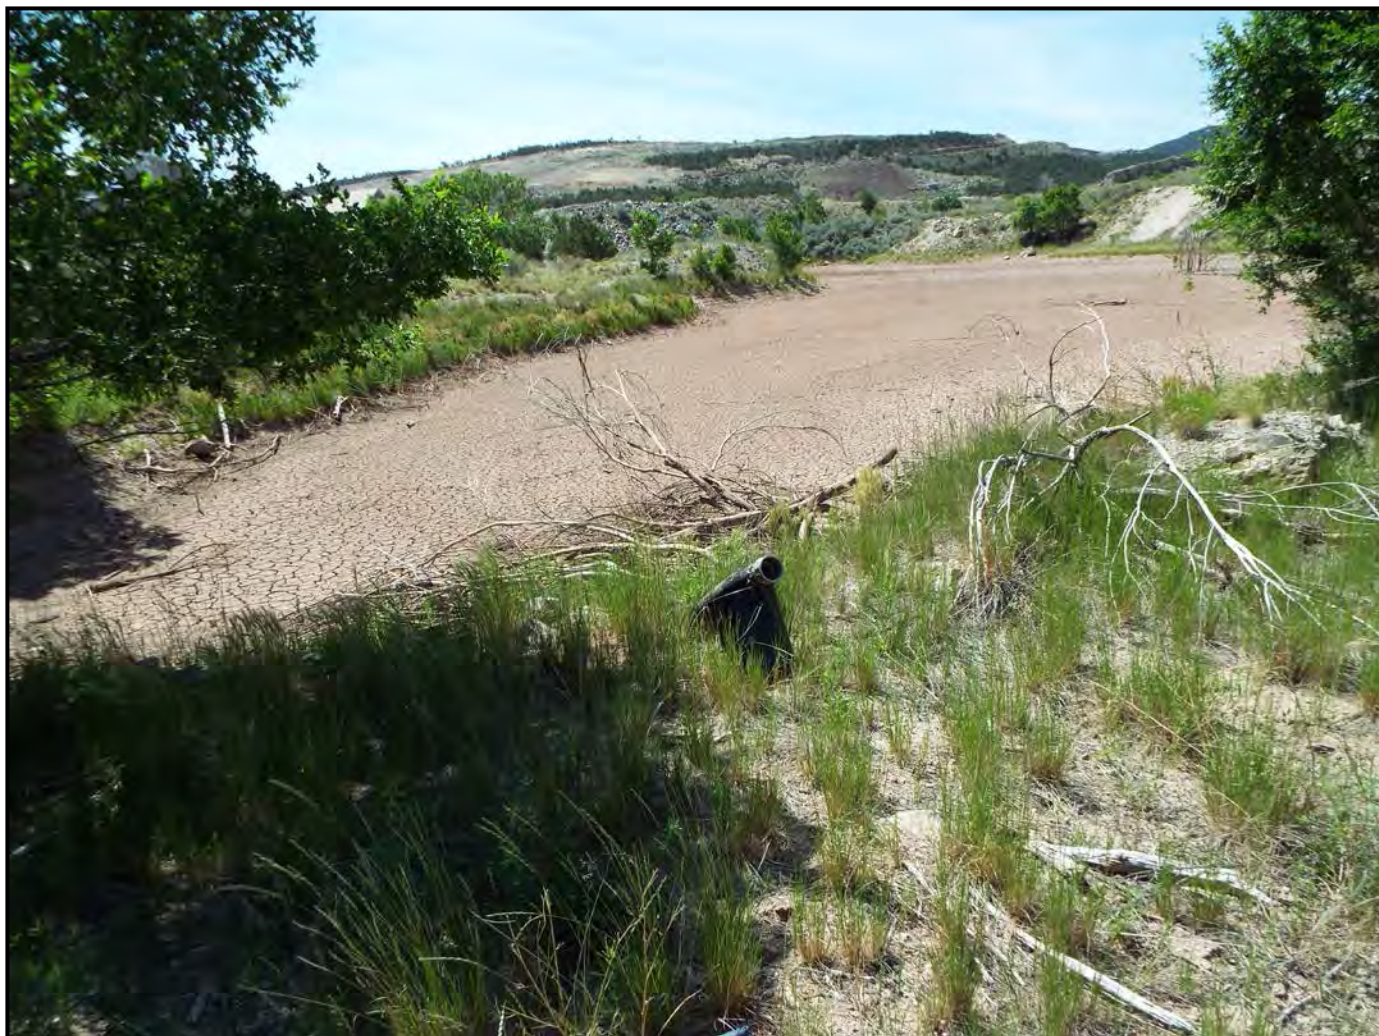
NMED/SWQB
Official Photograph Log
Photo # 1

Photographer: Daniel Valenta	Date: June 7, 2017	Time: 10:55 hours
City/County: Tijeras/Bernalillo		
Location: GCC Rio Grande Inc. Tijeras Plant, 11783 State Hwy 337 South, Tijeras, NM 87059		
Subject: Quarry pond above Outfall 001. Note hose hookup, when the pond fills a pump is used to drain water through Outfall 001.

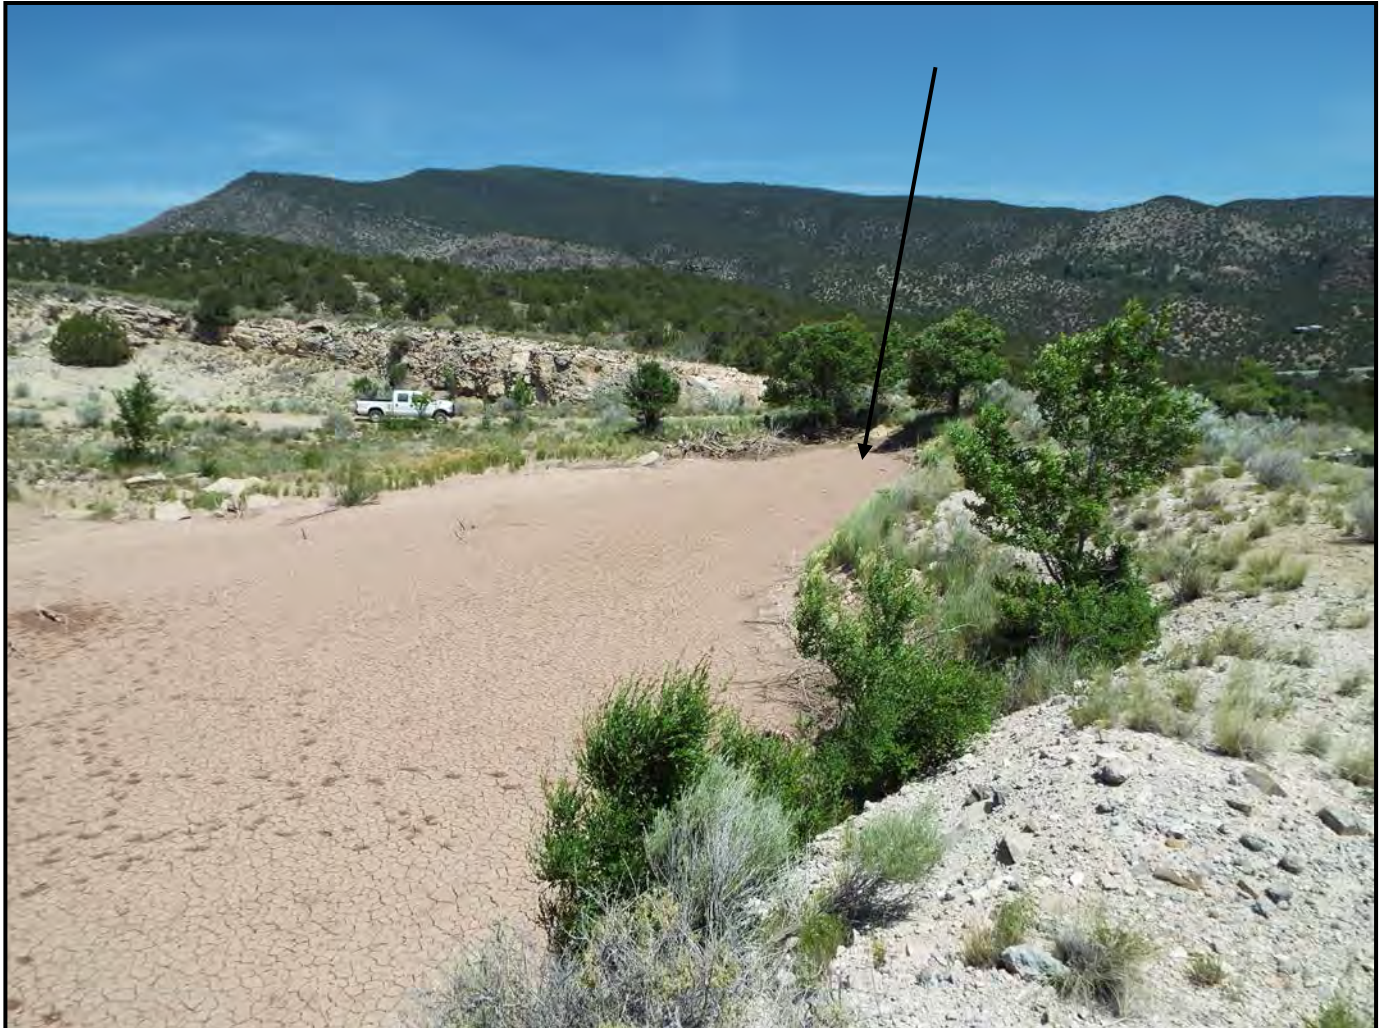
NMED/SWQB
Official Photograph Log
Photo # 2

Photographer: Daniel Valenta	Date: June 7, 2017	Time: 11:09 hours
City/County: Tijeras/Bernalillo		
Location: GCC Rio Grande Inc. Tijeras Plant, 11783 State Hwy 337 South, Tijeras, NM 87059		
Subject: Quarry pond, looking northwest towards Outfall 001.

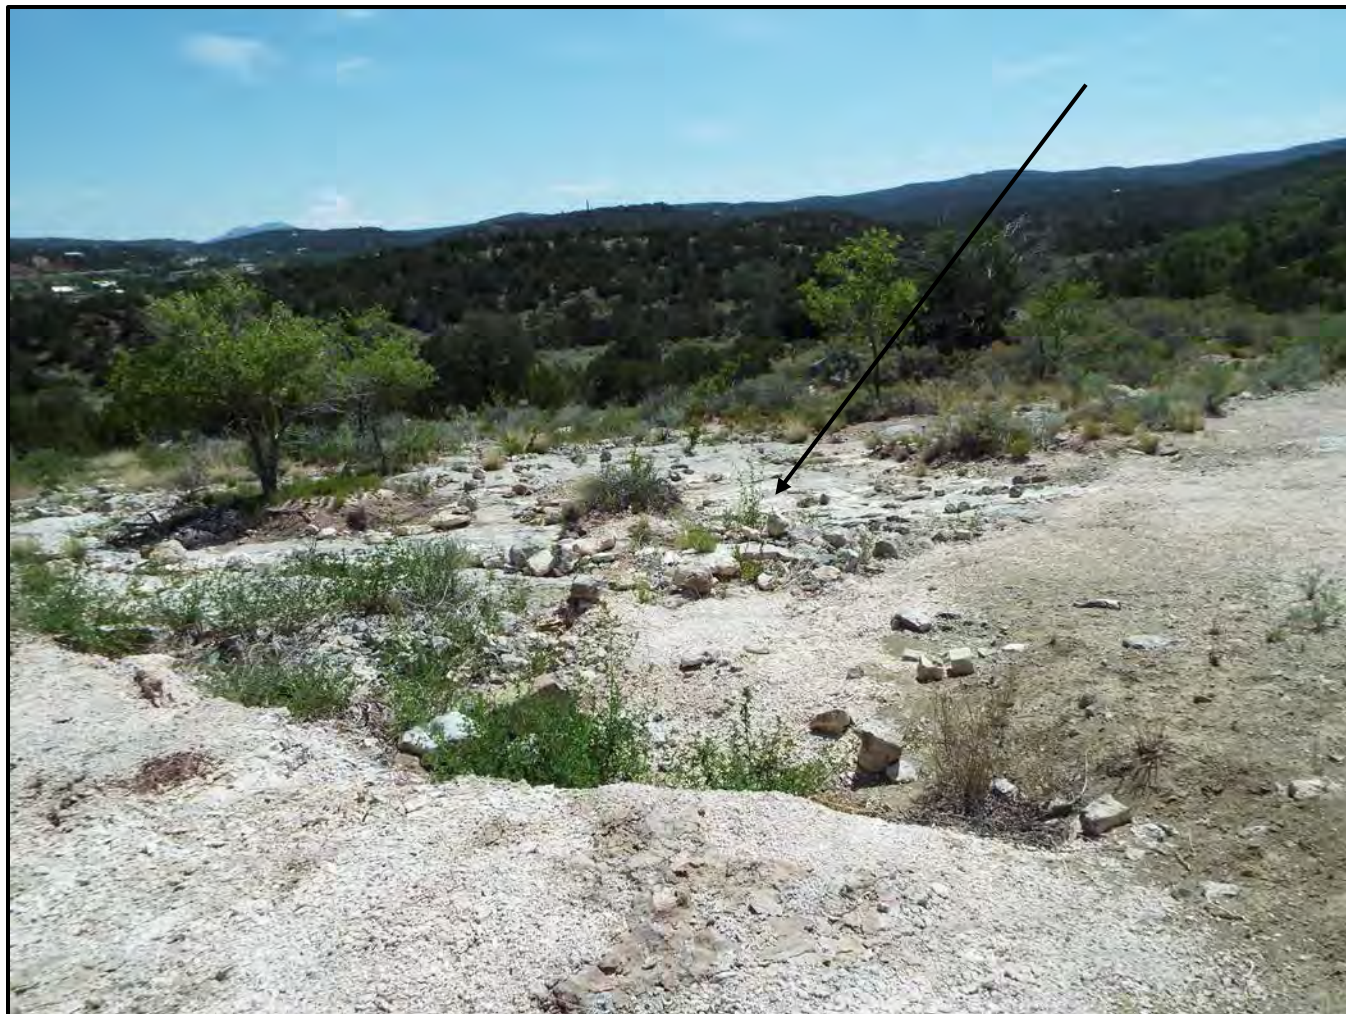
NMED/SWQB
Official Photograph Log
Photo # 3

Photographer: Daniel Valenta	Date: June 7, 2017	Time: 10:57 hours
City/County: Tijeras/Bernalillo		
Location: GCC Rio Grande Inc. Tijeras Plant, 11783 State Hwy 337 South, Tijeras, NM 87059		
Subject: Quarry outfall 001.

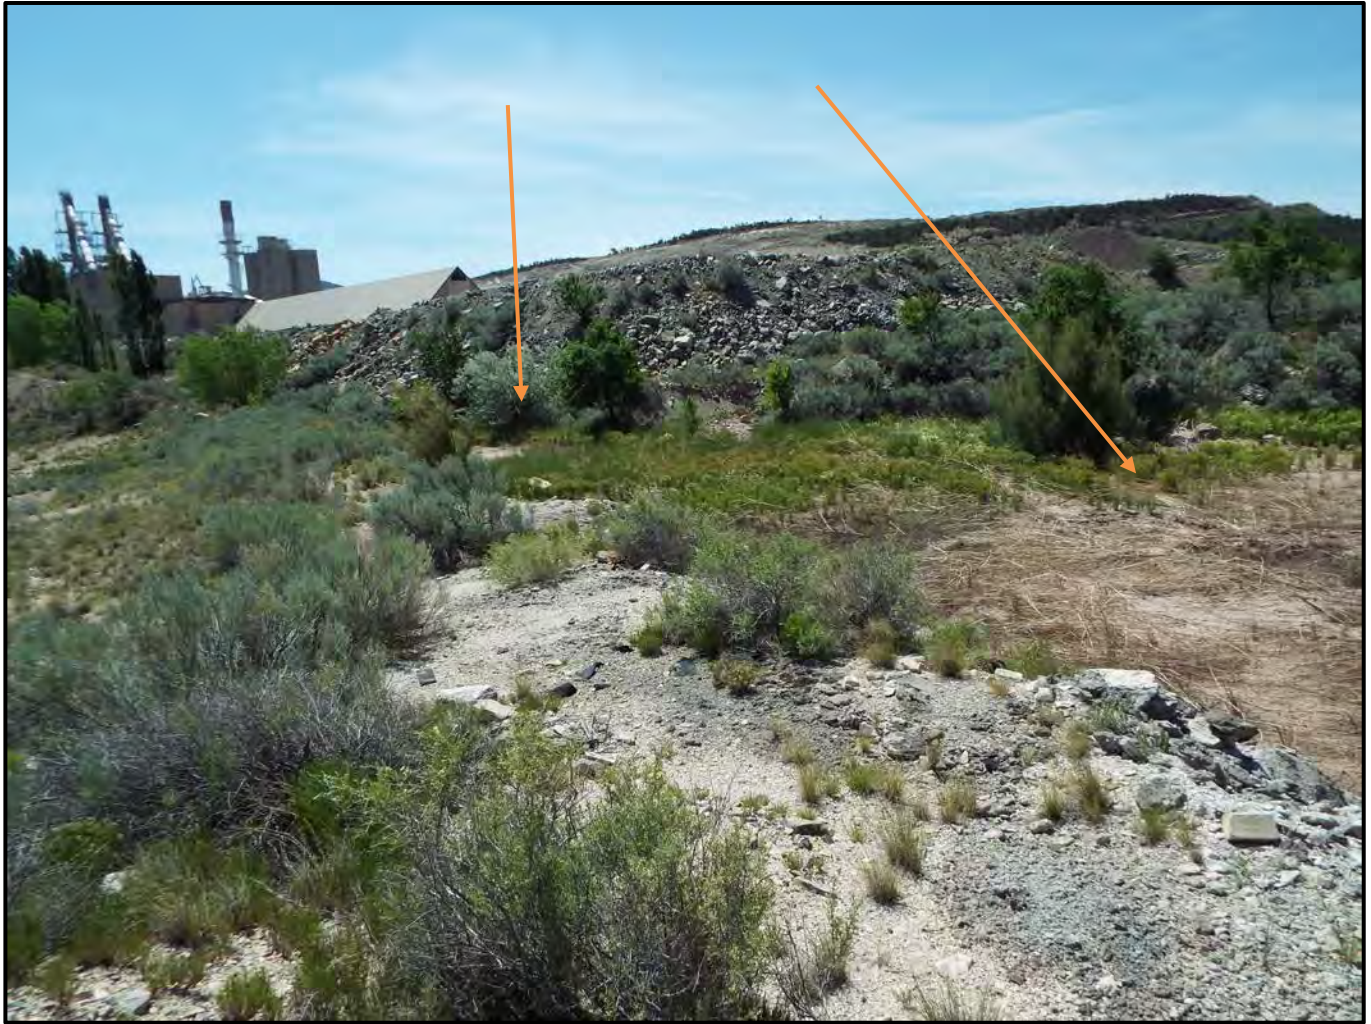
NMED/SWQB
Official Photograph Log
Photo # 4

Photographer: Daniel Valenta	Date: June 7, 2017	Time: 11:06 hours
City/County: Tijeras/Bernalillo		
Location: GCC Rio Grande Inc. Tijeras Plant, 11783 State Hwy 337 South, Tijeras, NM 87059		
Subject: Stormwater falling on the process part of the facility drains into the quarry pond.

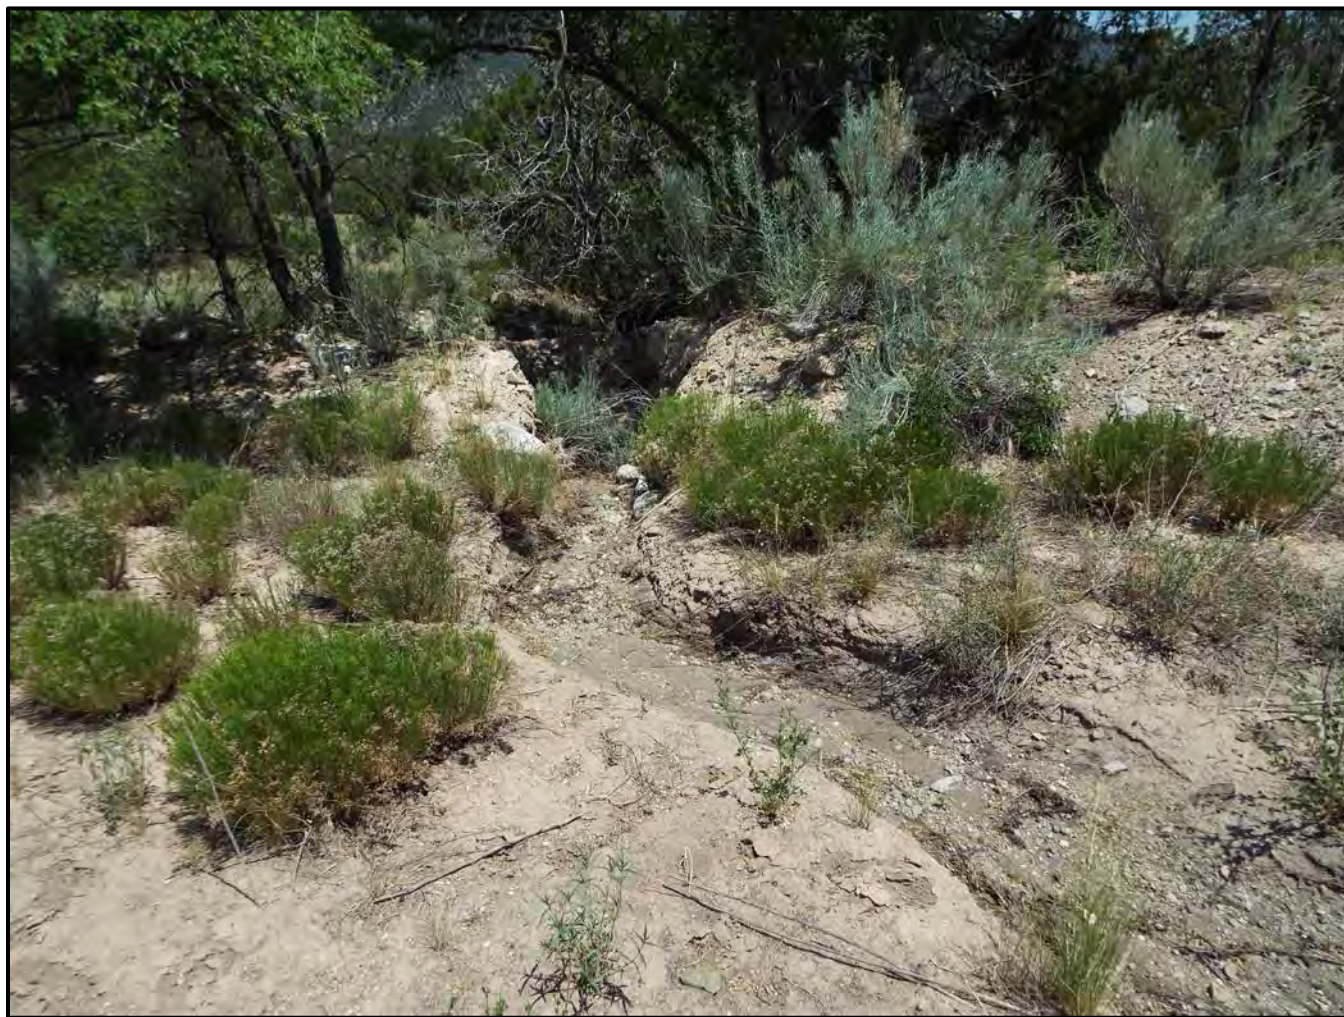
NMED/SWQB
Official Photograph Log
Photo # 5

Photographer: Daniel Valenta	Date: June 26, 2017	Time: 11:38 hours
City/County: Tijeras/Bernalillo		
Location: GCC Rio Grande Inc. Tijeras Plant, 11783 State Hwy 337 South, Tijeras, NM 87059		
Subject: The settling pond and Outfall 004 was never constructed; however, it appears discharges have been occurring. No samples have been taken at unpermitted outfall.

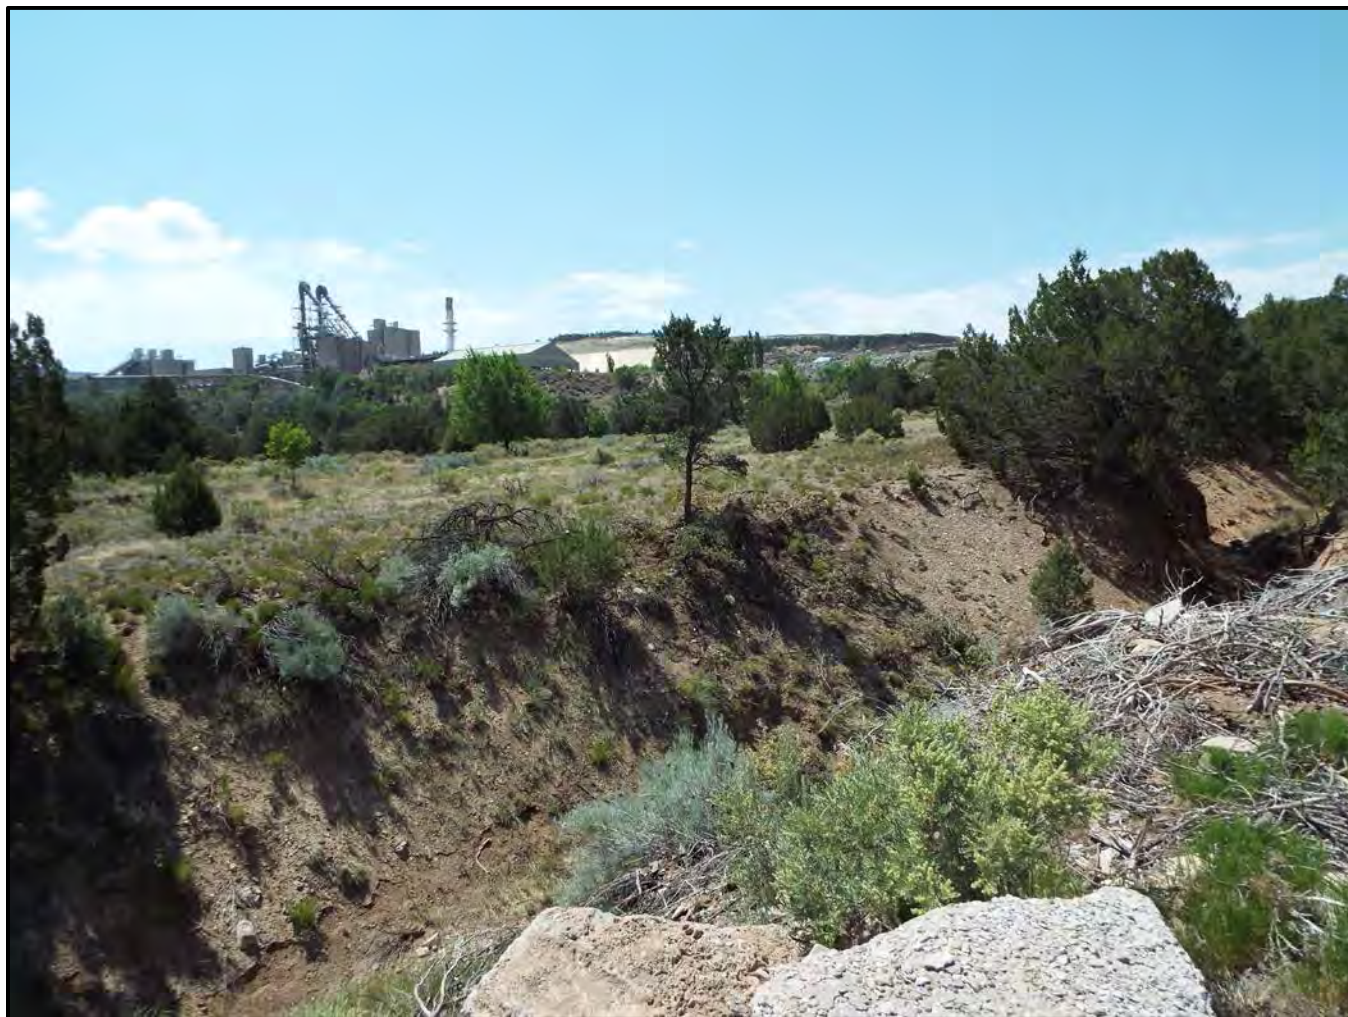
NMED/SWQB
Official Photograph Log
Photo # 6

Photographer: Daniel Valenta	Date: June 26, 2017	Time: 11:07 hours
City/County: Tijeras/Bernalillo		
Location: GCC Rio Grande Inc. Tijeras Plant, 11783 State Hwy 337 South, Tijeras, NM 87059		
<p>Subject: Discharges from the facility have eroded deep channels on the property next to the facility.</p> <p>Downcutting can be seen below Outfall 001 and Proposed Outfall 004, see photo 5. These two outfalls merge into the arroyo below.</p>

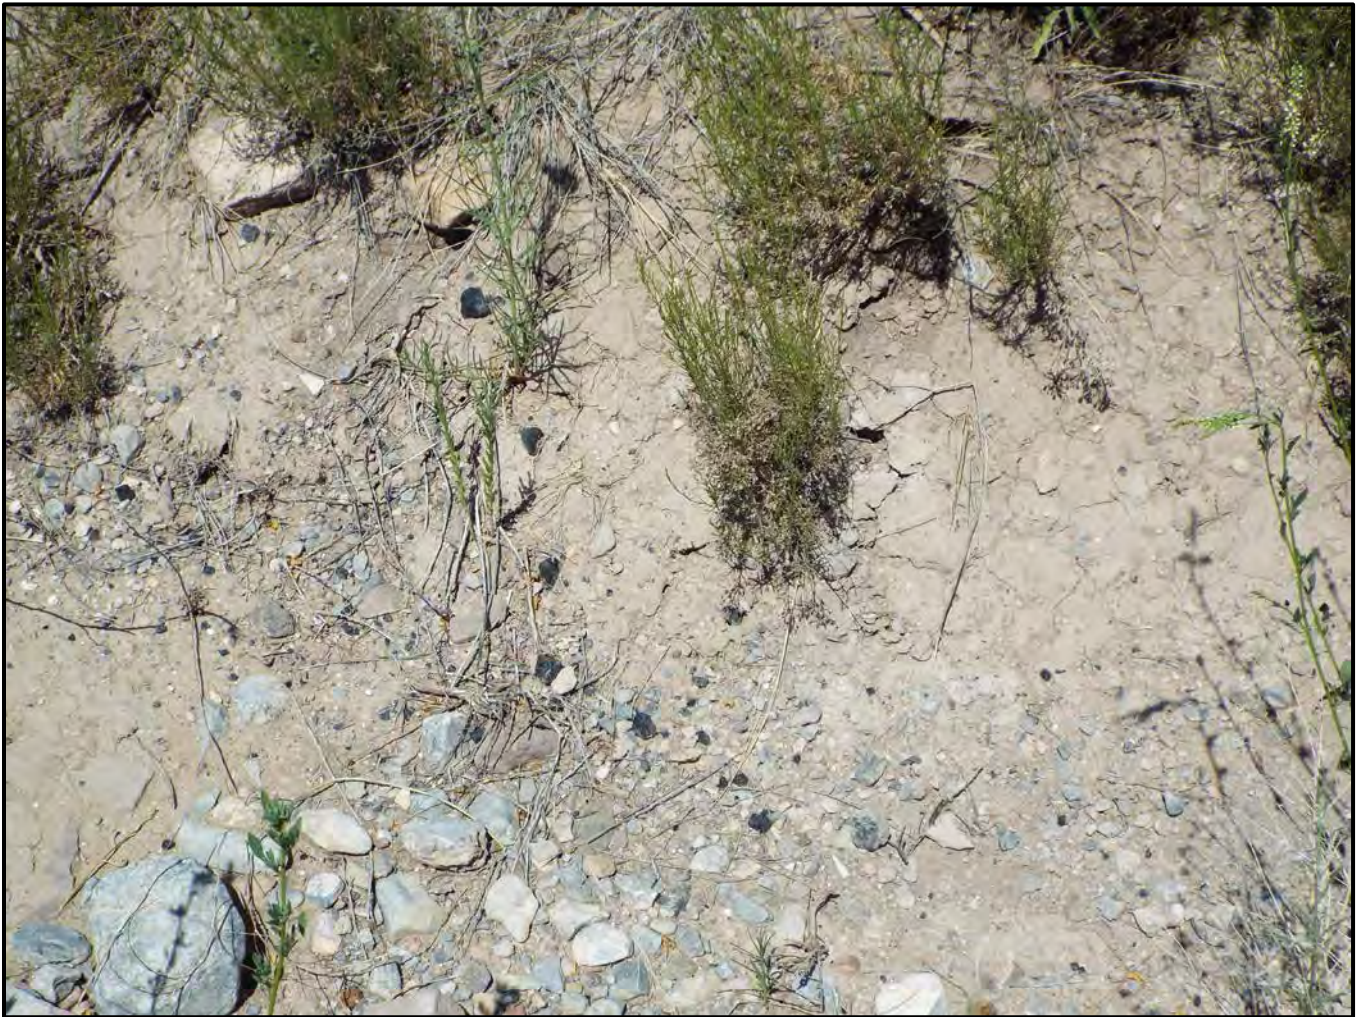
NMED/SWQB
Official Photograph Log
Photo # 7

Photographer: Daniel Valenta	Date: June 26, 2017	Time: 11:38 hours
City/County: Tijeras/Bernalillo		
Location: GCC Rio Grande Inc. Tijeras Plant, 11783 State Hwy 337 South, Tijeras, NM 87059		
Subject: Small bits of what appears to be coal bits can be found throughout the arroyo. Coal is stored on the north side of the facility near the proposed Outfall 004.
